**UNITED STATES AIR FORCE**  
**AIRCRAFT ACCIDENT INVESTIGATION**  
**BOARD REPORT**

**E-4B, T/N 73-1676**

**55<sup>th</sup> WING**  
**OFFUTT AIR FORCE BASE, NEBRASKA**

**DATE OF ACCIDENT: 12 MAY 2010**

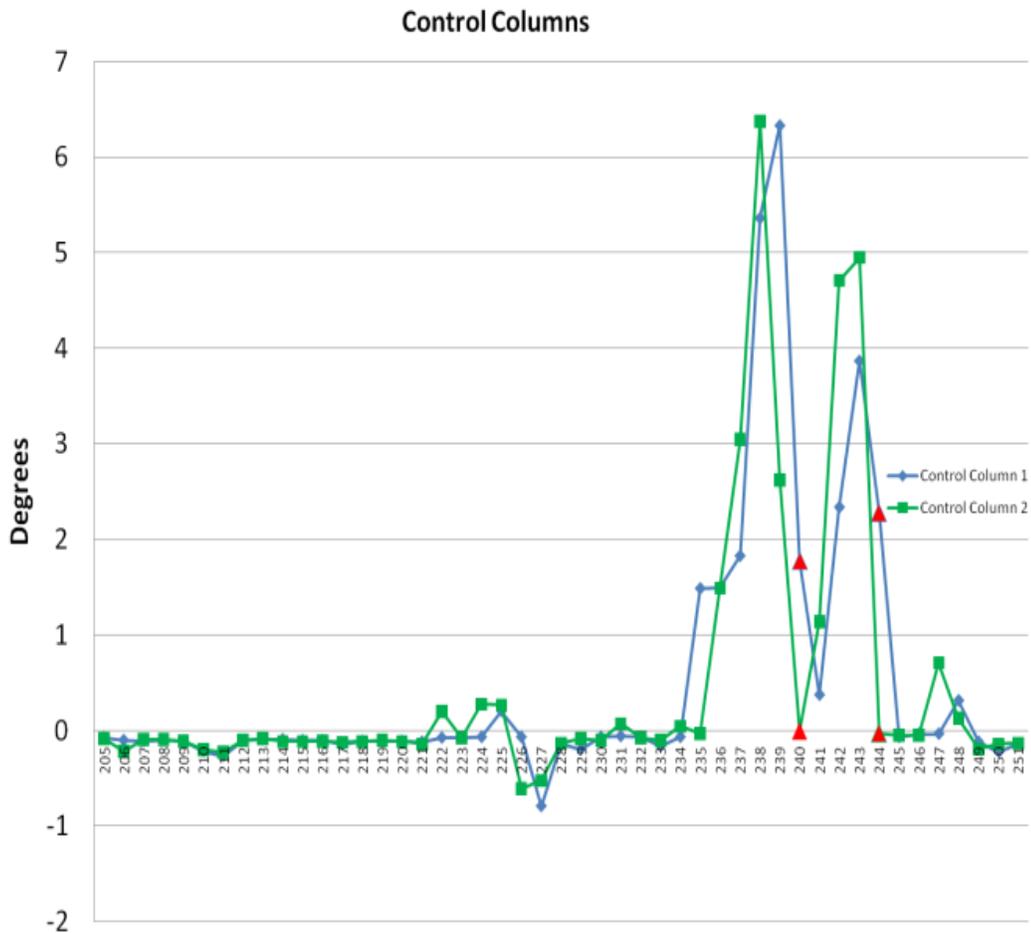
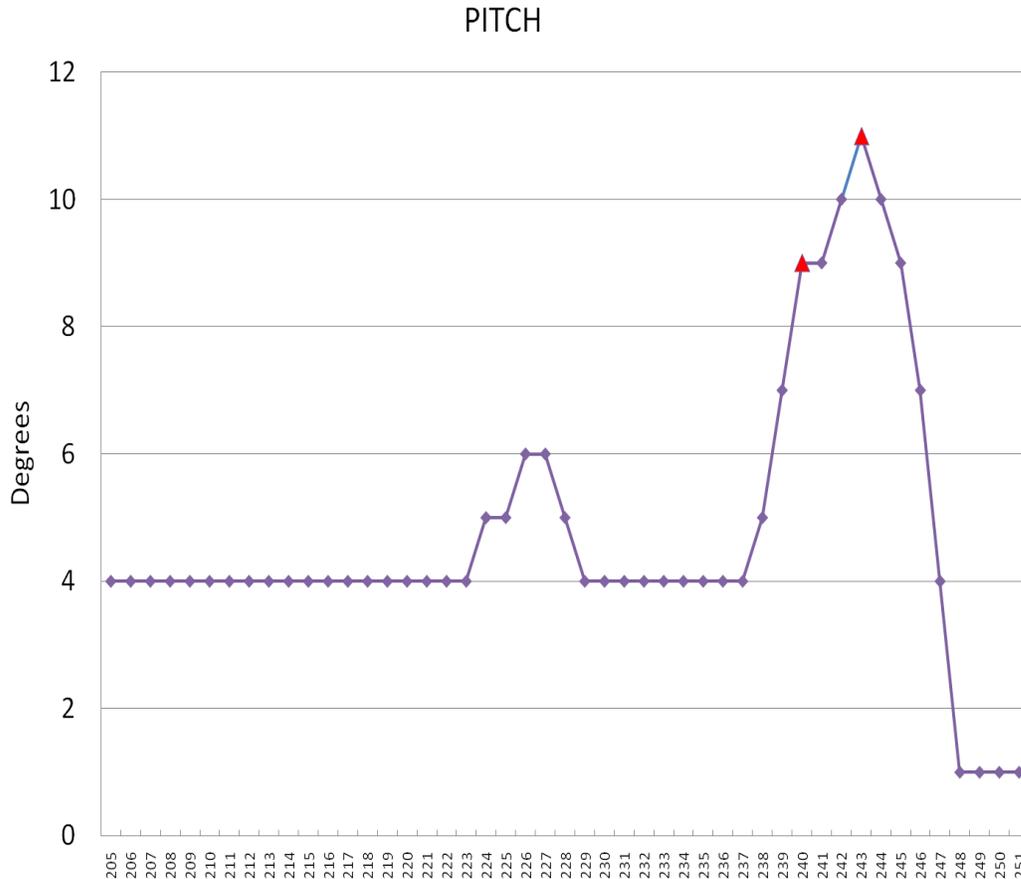
Immediately after the initial touchdown, the MA became airborne again, with no members of the MC immediately aware they were airborne (Tab V-6.18). Upon the first touchdown, MP1 had initially relaxed aft control column pressure (released backpressure on the yoke) (Tab DD-3). However, when he realized the MA was again airborne, MP1 pulled back on the yoke again in an attempt to smooth the subsequent landing (Tabs DD-3 and V-4.13). While airborne from the bounce, pitch on the MA came up to approximately 11 degrees, due in part to MP1’s aft control column input (Tabs DD-3 and DD-6). As the MA then settled back towards the runway, portions of the lower aft fuselage made contact with the runway surface, causing a “tail strike” (Tab V-4.14).

The result was that the aircraft initially touched down in a firm landing, with a 9-degree pitch attitude. The first touchdown point was 500 feet past the threshold (approximately 500 feet prior to the PAPI point of intercept and the thousand foot “Captain’s Bars” runway marking). The firm landing and the pitch attitude caused the MA to rise off the runway in a bounce. After the initial touchdown and during the bounce, the spoilers automatically deployed and MP1 pulled back on the yoke again. The combination of both of these actions increased the pitch attitude to 11 degrees prior to the MA touching down again. Since the MA was at 11 degrees of pitch, the tail section of the aircraft struck the runway.

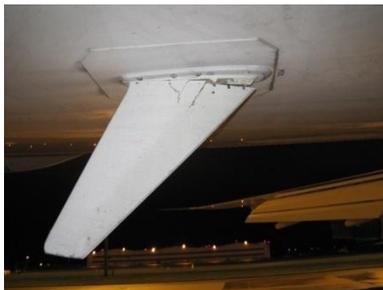
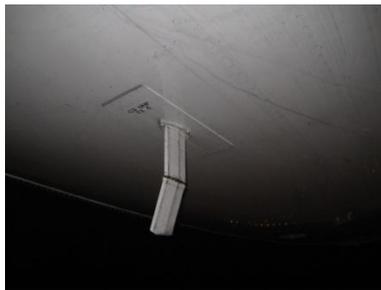
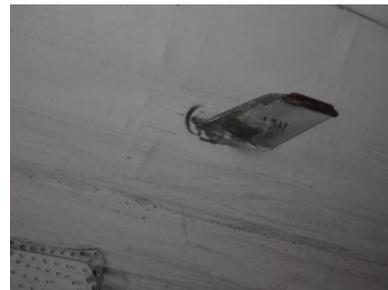
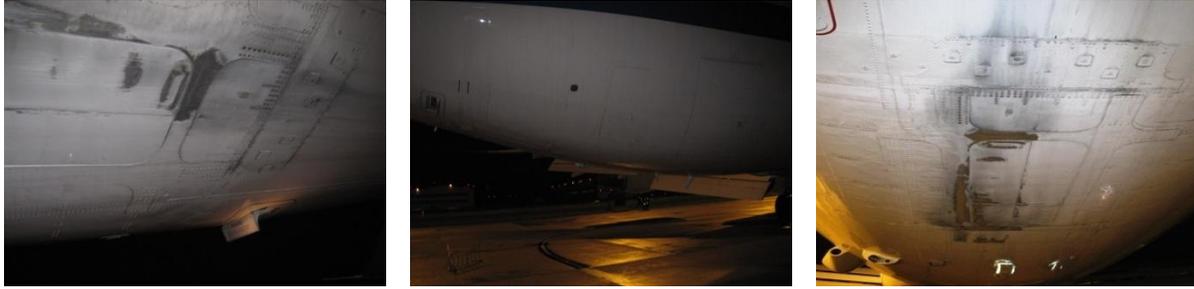
At approximately 2310 local time, at approximately 1,300 feet past the approach end threshold of RW 30, the tail section of the MA struck the ground approximately 2-3 feet to the right of the centerline nearly simultaneously to the landing gear touching down (Tab II-6). The MA sustained damage under the fuselage tail area that contacted the runway, as described in section 6 below.

After landing, the MA taxied under its own power after the mishap and was inspected by Quality Assurance and 55 WG Safety personnel. Damage to the aircraft was photographed immediately following the mishap after the aircraft taxied to parking. (Tabs S-7 through S-14). The aircraft sustained substantial damage from Body Station (BS) 1800 to BS 2320 on the belly of the aircraft. External damage to the very high frequency data link antenna, a command, control, and communications (C3) “receive” antenna, drain mast next to the long trailing wire antenna doors, aircraft left outflow valve, and the drain mast for the aft lavatories was visible upon landing, along with scrapes along the skin (Tab P-3). No relevant pre-existing defects were noted.
