UNITED STATES AIR FORCE
AIRCRAFT ACCIDENT INVESTIGATION
BOARD REPORT

MQ-1B, S/N 07-3200

**27th Special Operations Wing
3rd Special Operations Squadron
Cannon Air Force Base, New Mexico**

DATE OF ACCIDENT: 28 July 2010

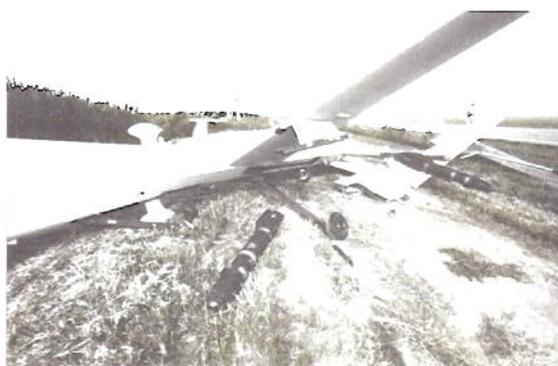
Impact site

The AIB investigated post-mishap photographs of the perimeter fence impact site, the preserved physical evidence of the MRPA's wreckage and the GA engineering analysis report. Photographs taken at the mishap site revealed the MRPA wreckage remained in a fairly compact area at the point of impact (Tab Z-1). All aircraft structures and systems were found in the immediate vicinity of the main fuselage, at or near their original orientation, within close proximity of their normal configuration (Tab Z-1).

The MRPA main fuselage was resting intact on its right wing root with little noticeable external damage. However, the forward fuselage sustained significant internal damage when the nose landing gear drove up through the avionics bay, causing the antenna to pierce the radome (DD-10). The shock mounts from the forward avionics bay were pulled out (Tab DD-10). The MTS was pushed-up through the avionics tray damaging the ball (Tab DD-10). The nose wheel was bent at a 90 degree angle from the strut (Tab DD-10). Both main landing gear were attached (Tab DD-10). The lower antenna was sheared off (Tab DD-10). The A-frame and V-block were torn in pieces and the bulkhead cracked (Tab DD-10). There was evidence the fuselage torqued just aft of the right wing root (Tab DD-10).

The left wing remained attached but had holes in the trailing edge for approximately the last six feet. The right wing was torn-off and incurred damage along the trailing edge at approximately mid-wing. It came to rest inverted in the fence, behind and slightly to the left of the fuselage. The vertical tail remained attached, but was bent 90 degrees. The left tail was attached, but incurred damage to the leading edge. The right tail was torn off and came to rest on the fence, aft and to the left of the fuselage.

The engine remained intact. Both engine cowls were cracked through the composite. A separation of the composite occurred forward of the fuel tray near the IFF antenna. The spinner cone remained intact but all propeller blades separated and were found within relative close proximity to the MRPA impact site.
