**UNITED STATES AIR FORCE**  
**AIRCRAFT ACCIDENT INVESTIGATION**  
**BOARD REPORT**

**F-16CM, T/N 89-2144**

**4TH FIGHTER SQUADRON  
388TH FIGHTER WING  
HILL AIR FORCE BASE, UTAH**

**DATE OF ACCIDENT: 8 OCTOBER 2010**

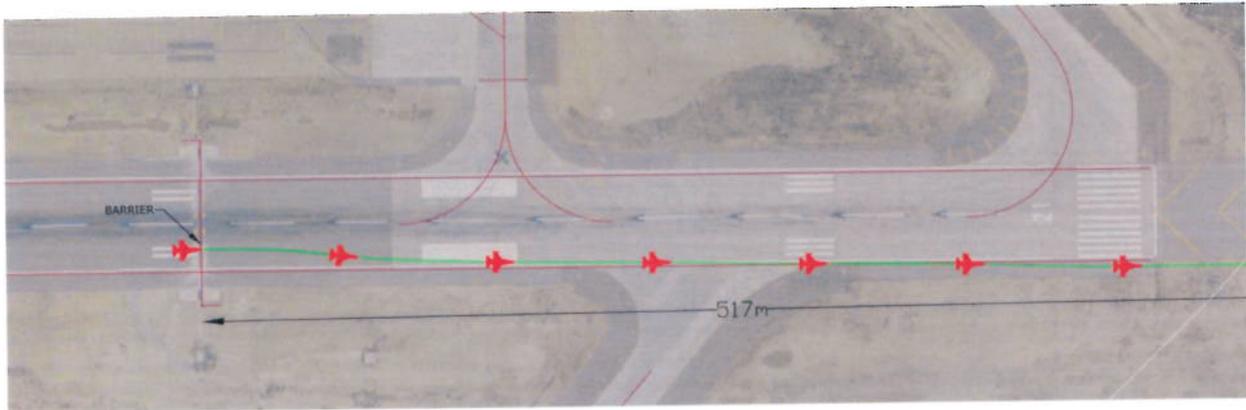
**Figure 1. Diagram of MA Runway Landing Path**

After touching the nose down, the MP properly applied the brakes. The MP recalled that upon initially applying wheel brakes, they functioned normally. However, shortly thereafter the MP felt the brakes abnormally cycling and the MA pulling to the right. (Tab V-1.14) The brake failure occurred with approximately 3900 feet of runway remaining. In accordance with the brake failure checklist, the MP released the brakes and switched from Channel 1 to Channel 2. (Tabs V-1.22, BB-14 thru BB-15)

The MA's brake system has a redundant electrical and hydraulic design, allowing the pilot to switch to a different control channel should one fail. (Tab V-3.3) After switching to Channel 2, the MP first noticed the anti-skid caution light, indicating a failure possibly affecting braking performance. (Tab V-1.29, V-5.2) The MP immediately applied brakes and felt no braking action at all. The MP maintained full left rudder in an attempt to remain on the centerline. (Tab V-1.22) Data from the anti-skid control box indicated the right brake was responding normally throughout the landing. The data indicated the left brake malfunctioned and did not respond to the MP's inputs. (Tabs J-25 thru J-30, U-7, V-3.22, V-3.26) F-16 aircraft are capable of differential braking, which allows the pilot to control the left and right brakes independently. This capability allows the pilot to steer the aircraft simply through brake application. For example, if the pilot only applied the right brake, the plane would steer to the right. (Tabs V-3.35 thru V-3.36) Based on the MA's left brake failure, every time the MP applied the brakes, only the right brake functioned, causing the MA to veer to the right. (Tabs V-3.32 thru V-3.34) (See Figure 1)

After missing the cable, the MP reapplied brake pressure, pulling the MA further to the right due to the continued left brake failure. (See Figure 1) The MP then made a radio call to the Air Traffic Control tower that the MA was going off the end of the runway. (Tab V-1.19) The CSFDR data indicates the MA was traveling 67 knots as it departed the runway. (Tabs L-3 thru L-8) The MP shut the engine off prior to departing the edge of the runway. (Tab V-1.19)

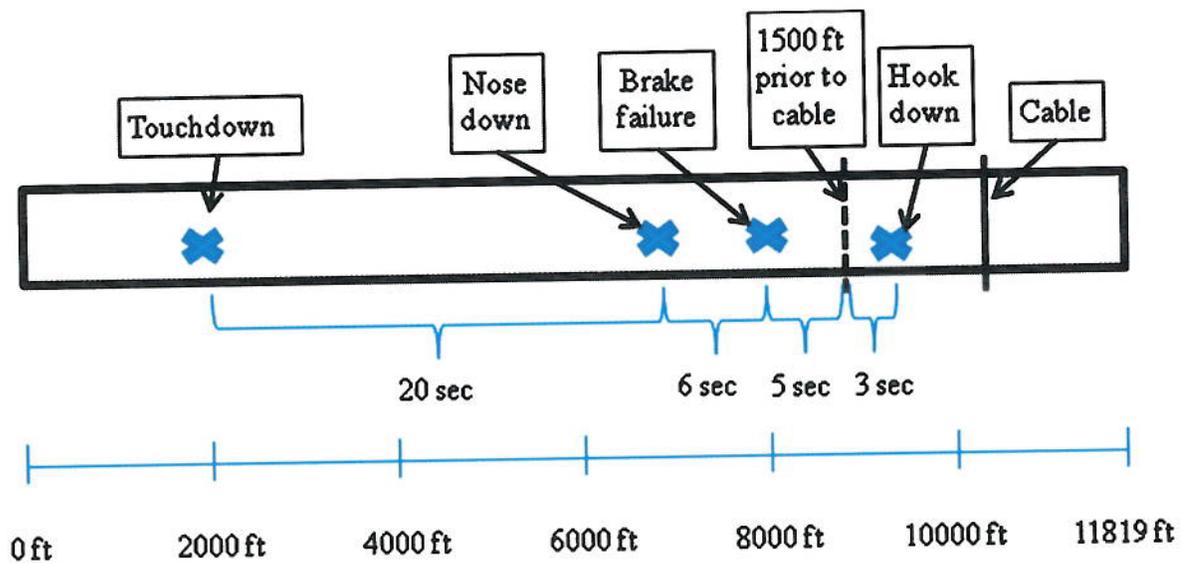
Figure 2. BAF Runway Diagram with Approximate Action Points

Based on the MP's assessment of brake failure in Channel 2, the next step in the brake failure checklist is to lower the hook in an attempt to engage the arresting cable. The arresting cable, also known as a barrier, is a tensioned wire running perpendicular across the runway designed to catch a hook that drops down from fighter aircraft. (Tab V-1.15) At BAF, the cable is located 1500 feet from the end of the runway. (Tab BB-52) Based on measurements taken shortly after the mishap, the arresting cable was approximately 2.13 inches above the runway surface. The cable was .25 inches below the recommended height, but above the minimum height requirement of 1.5-1.75 inches. (Tabs J-5, BB-53 thru 56) Regulations state that pilots shall drop the hook at least 1500 feet prior to the departure end cable to ensure a successful engagement. (Tabs V-1.24, BB-16) The MP recalled dropping the hook at approximately 1000 feet prior to the cable. (Tabs V-1.15, V-1.28)

Based on CSFDR data, the MP only had five seconds to recognize and react to brake failure in order to lower the hook prior to 1500 feet. (Tabs L-3 thru L-8) In these five seconds, the MP would have to release all brakes, switch to Channel 2, reapply the brakes, recognize continued brake failure, and then lower the hook. It took the MP eight seconds to complete all of these actions. Therefore, the MP was unable to lower the hook within the 1500-foot parameter. (Tabs BB-14 thru BB-16) The MA passed over the cable but did not engage it. (See Figure 2) Figure 2 below is based on witness testimony, CSFDR data, and data from ground markings.

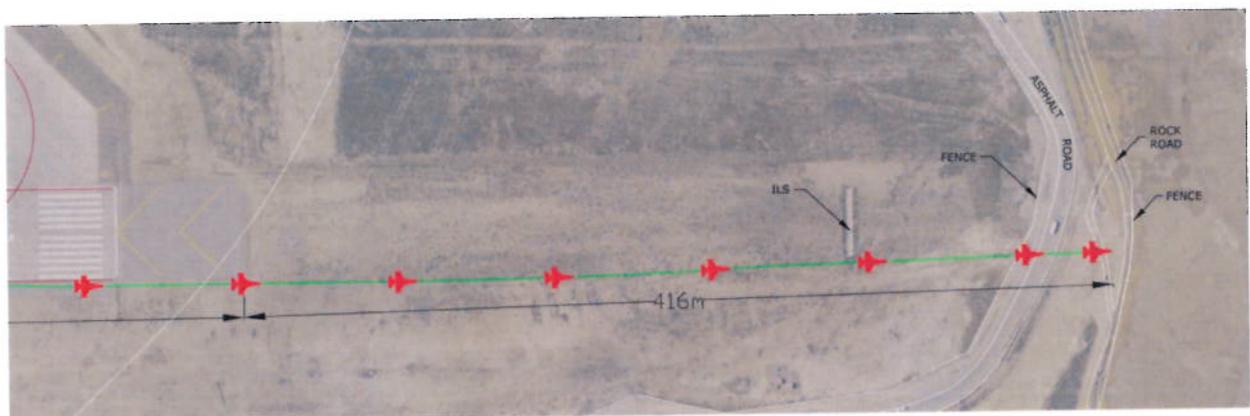
Figure 3. Diagram of Post-Runway MA Path

The MP continued using the rudder to steer the aircraft as it traveled approximately 1500 feet across the dirt, narrowly missing the Instrument Landing System antennas. (Tab V-1.20) The MP braced for impact as the MA passed through a chain link fence. The MA then impacted a raised perimeter road, which collapsed the landing gear. The MA then became airborne for a short distance and came to rest partially entangled in a second chain link fence. The MP performed an emergency ground egress at approximately 1720L. (Tabs V-1.20 thru V-1.21)

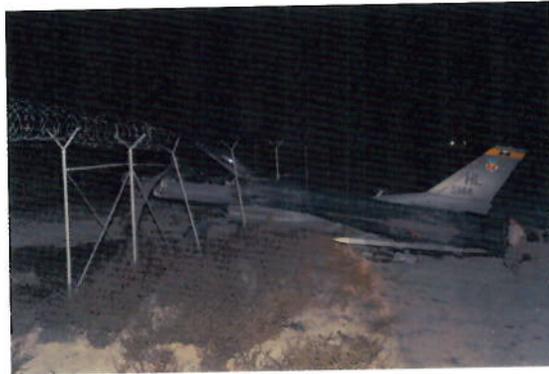
**Figure 4. MA Final Resting Position**

The MA came to rest approximately 1500 feet from the end of the runway. The MA crossed BAF's perimeter road and stopped entangled in the second fence at 1718L. (See Figures 3 and 4)

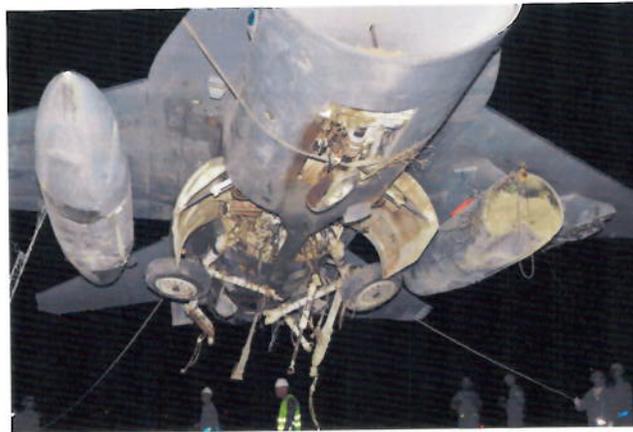
**Figure 5. Post Impact Damage**

The MA's fuselage remained mostly intact. The landing gear collapsed and all three struts sustained significant damage but did not separate from the MA. The nose landing gear components collapsed in the aft position consistent with normal retraction. Both main landing gear struts collapsed aft, opposite the normal forward retraction direction, resulting in substantial damage to the lateral structural bulkheads. All three tires and both main landing gear brake stacks remained attached to the landing gear struts. The forward fuselage was deformed with partial separation of the radome. Both wings remained attached, but sustained dents and abrasions along the entire leading edge. The horizontal and vertical stabilizers remained attached, with both the left and right horizontal stabilizer tips sustaining impact damage. Both ventral fins remained attached but sustained significant damage. (Tabs S-6 thru S-18)

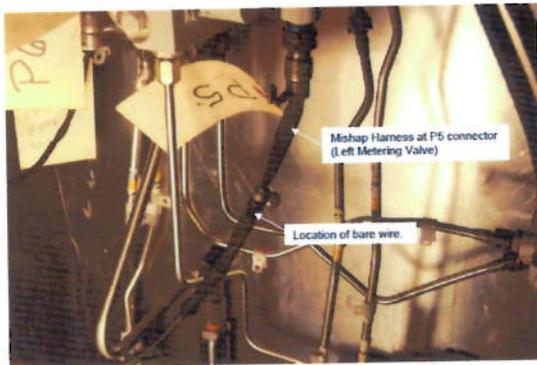
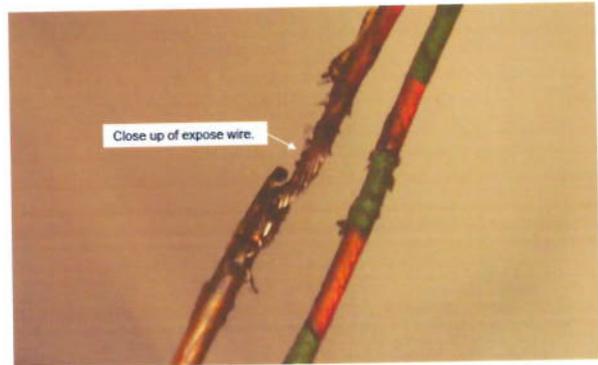
Chafing of the wiring harness created a condition where a bare wire came in contact with a clamp, resulting in metal-to-metal contact and a short circuit. This chafing occurred over time through normal wear and tear of the Kapton wire used when the MA was originally manufactured. No regular inspection would have revealed this chafing. (Tab U-9) The short circuit occurred in the wiring harness between the anti-skid control box and the left metering valve. The short circuit affected both redundant brake channels. (Tabs J-25 thru J-30, U-5 and V-3.27)

**Figure 6. MA Wiring Harness**

**Figure 7. MA Exposed Wiring**

Due to this short circuit condition, which occurred during the landing roll, electrical signals between the anti-skid control box and the left brake metering valve were interrupted. This created a condition where the hydraulic pressure exerted on the left brake was substantially lower than the input from the pilot, causing left brake failure. (Tabs J-28 and U-9)

During analysis of the data downloaded from the anti-skid control box, engineers determined that an electrical malfunction occurred during landing rollout. Through normal wear and tear, chafing of the main brake wiring harness caused a bare wire to come in contact with a clamp, resulting in metal-to-metal contact and a short circuit. Due to this short circuit, electrical signals between the anti-skid control box and the left brake metering valve were interrupted and caused failure of the left brake. This left brake failure caused the MA to drift to the right and fail to slow down before the end of the runway.

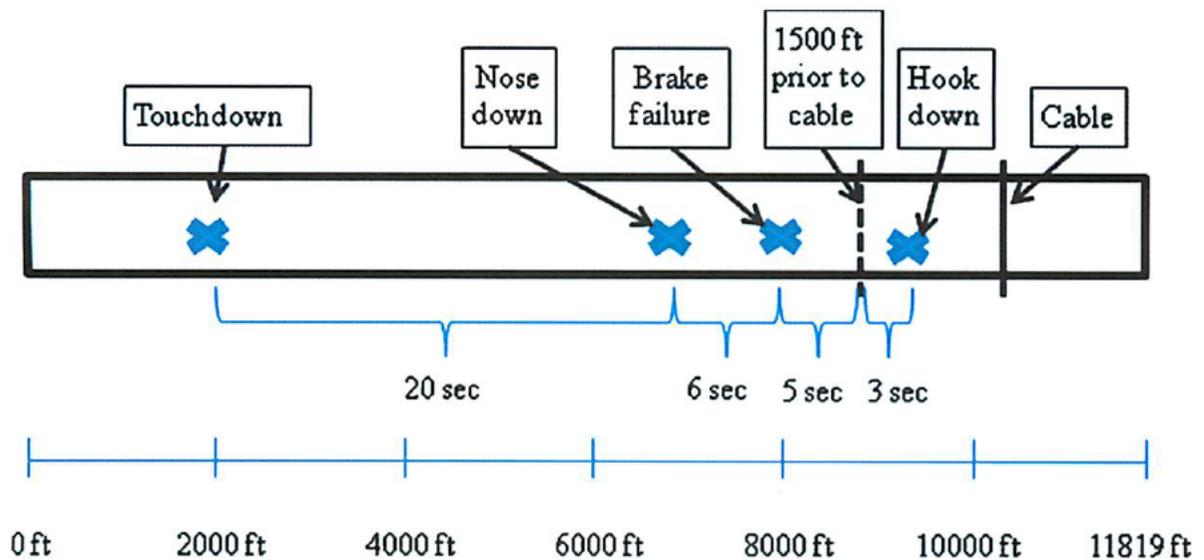
BAF Runway Diagram with Approximate Action Points

The above illustration portrays the relevant shifted and extended action points due to a long and heavy landing in this mishap. This left the MP with insufficient time to troubleshoot and effectively handle any complications during landing roll. Specifically, when the left brake failed, the MP took eight seconds to run through the first two steps of the brake failure checklist and lower the arresting hook. The MP actually had five seconds to lower the hook before the prescribed 1500 feet prior to the arresting cable. While the cable was suspended .25 inches below the prescribed height, it was still within operational range. I do not find that the cable's height was a factor in this mishap. Had the MA landed at the recommended touchdown point and fuel weight, the MP would have had more time to lower the hook within parameters and increase the likelihood of successfully engaging the cable.
