UNITED STATES AIR FORCE GROUND
ACCIDENT INVESTIGATION BOARD
REPORT

Tower Mishap Fatality
FOB Kalagush, Afghanistan

TYPE OF ACCIDENT: Class A Fatality

DATE OF ACCIDENT: 12 November 2010

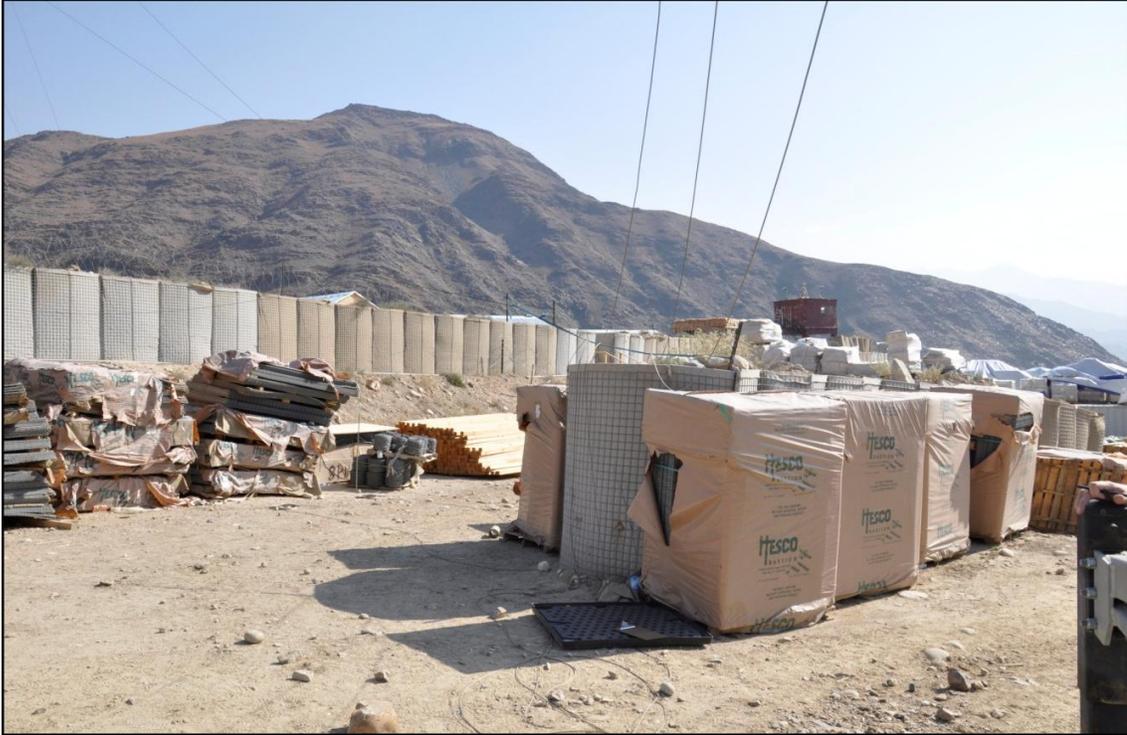
Figure 12. Protective Barriers in Between MCT's Anchor Point and the Tower.

The data obtained regarding the site conditions surrounding the tower indicated that there were obstructions around the tower in contradiction of published site selection guidance. Large HESCO barriers prevented the tower operator and MTI from being able to see the members at the curb-side and road-side anchor points. These HESCO barriers also prevented the members at the anchor points from being able to see the tower operator and each other. Furthermore, the guy cables had to go over the barriers in order to be secured to the anchor points, which presented multiple opportunities for the cables to get caught. Neither MTT nor MTI noticed that the member at the curb-side anchor point had connected a cable, nor did they notice that the curb-side and road-side members failed to maintain positive control of their guy cables. (Tabs R-29, R-30, R-109, S-5, and V-9, V-15, V-16, V-33, V-64, V-110, V-114, V-119, V-133)

The inappropriate site conditions had been pointed out to the previous commands at FOB Kalagush; however, the situation was not corrected until after the mishap. The obstructions prevented line of sight supervision and presented multiple opportunities for cables to get caught. The inappropriate site conditions resulted in an unsafe situation. (Tabs R-29, R-30, and CC-4)

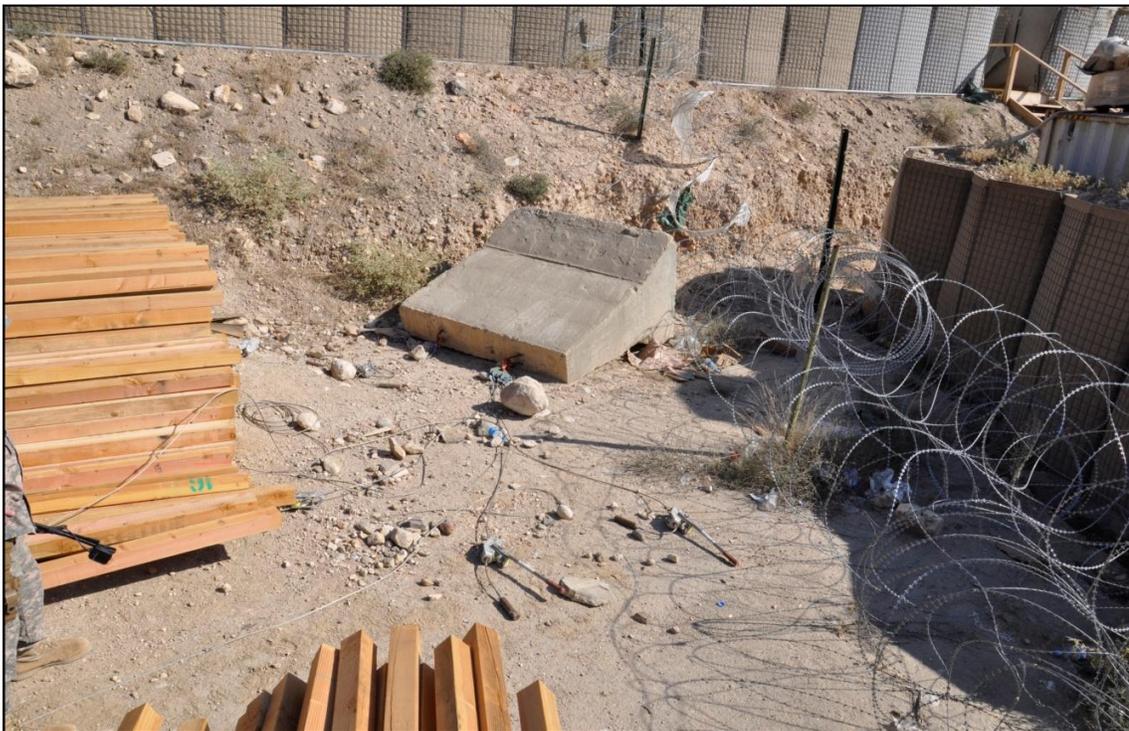
Figure 13. MCT's Anchor Point.

The testimony obtained indicated that two procedural errors occurred relevant to the mishap. First, the trainee manning the curb-side anchor point appeared to have connected a cable prior to the tower being fully extended. The second procedural error was that MV1 and MV2 were standing at the base of the tower while not actively engaged in tower operations. MTI should have ensured the area was clear of bystanders when the tower was being extended. Both of these errors resulted in an unsafe situation. (Tabs R-20, R-22, R-24, R-33, R-34, R-49 and V-12, V-13, V-61, V-62, V-63, V-64, V-96)

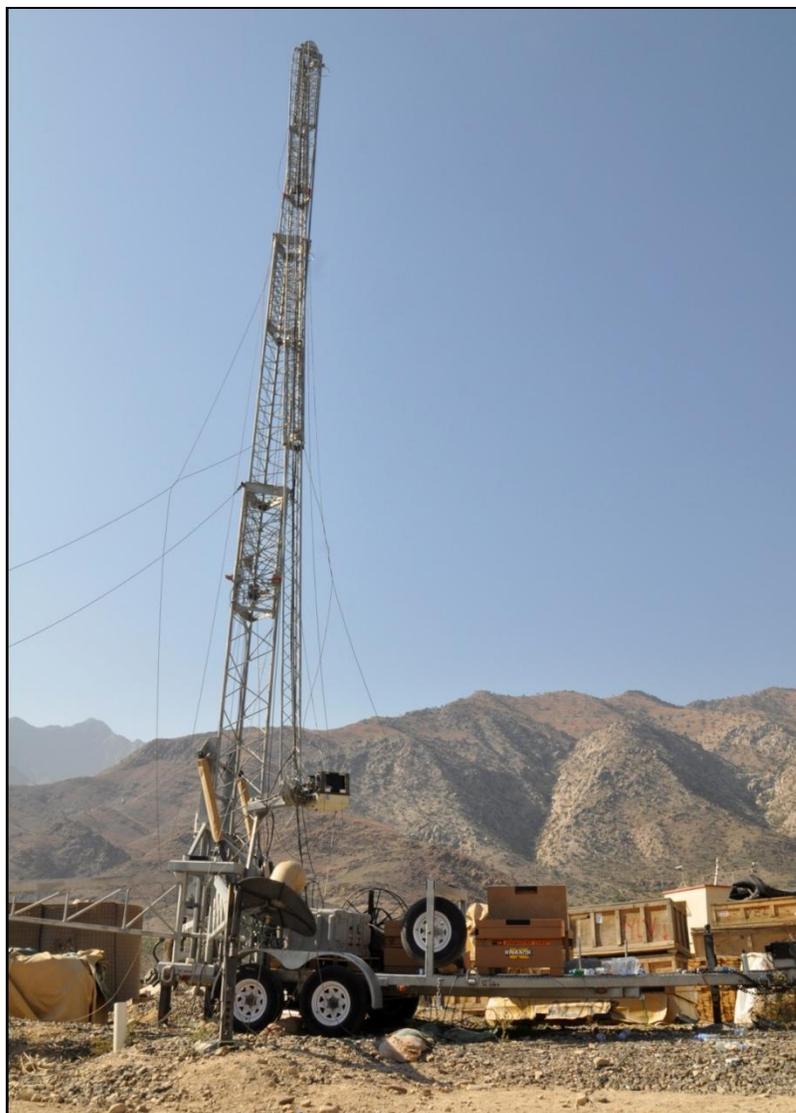
Figure 14. The Collapsed Tower (View from the Curb-side).

MV1 and MV2 were lying at the base of the tower on the curb-side. MV2 was on his back underneath the back outrigger leg, and MV1 was lying next to the trailer tires partially on his back and side. (Tabs R-8, R-12, R-56, R-107, and V-14, V-39, V-40, V-65, V-96, V-97, V-117)

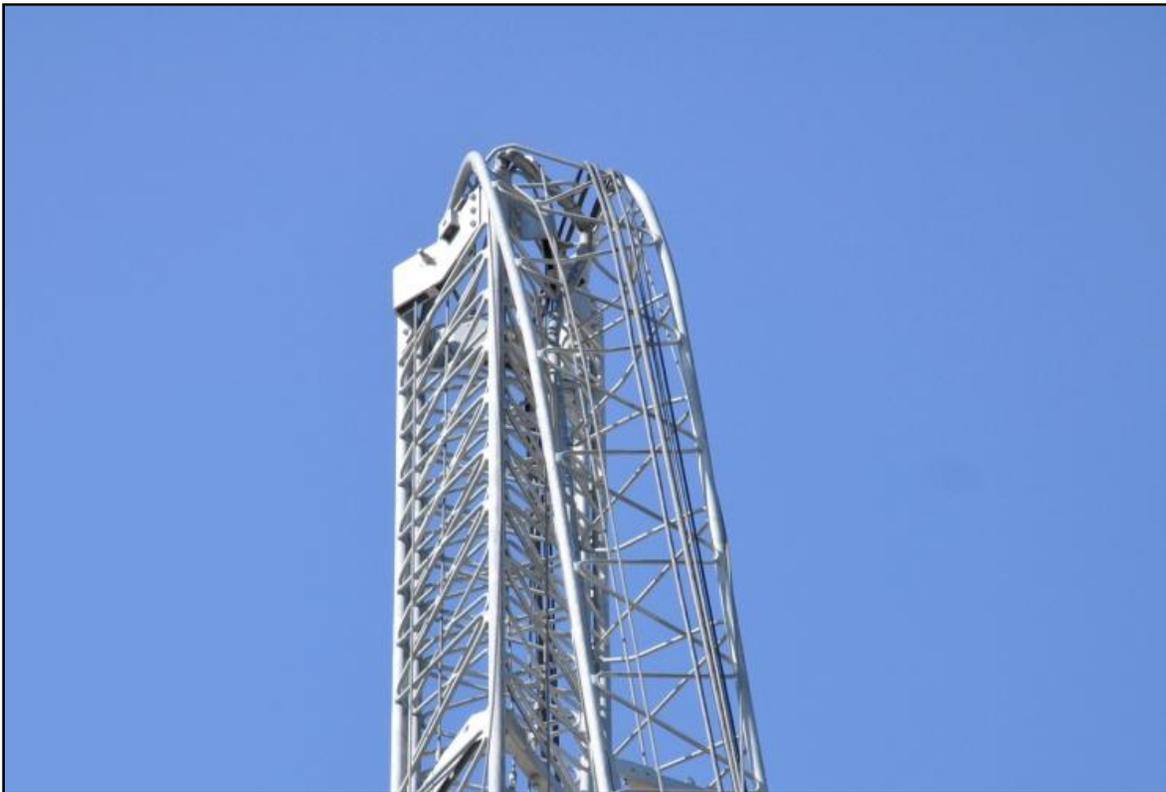
Figure 16. Close-up of Failure Point.

The collapse occurred when the fourth section of the tower collapsed to the curb-side and ultimately failed structurally. This occurred as the tower was nearly fully extended. (Tab R-3, R-8, R-20, and S-3)

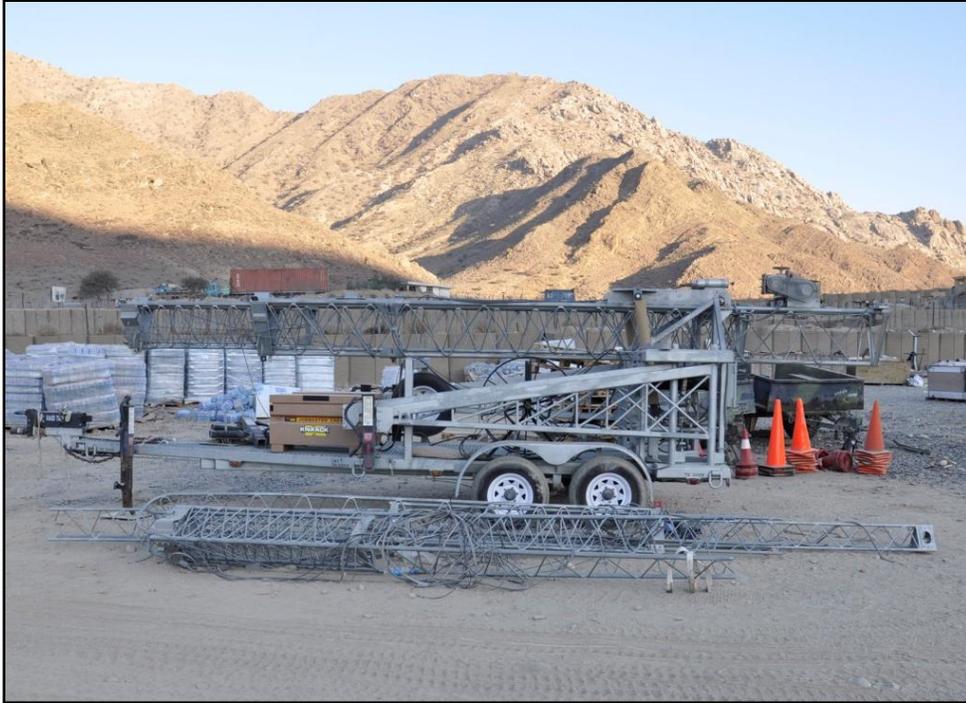
Figure 17. Disassembled Tower Post-Accident.

The collapse resulted in irreparable damage to Tower 89 as well as the communications antenna attached to it valued at \$305,000 and \$1,581, respectively. The tower was removed from service and cut apart for storage and shipment. A replacement MTU 3107 tower was installed at Kalagush in early December 2010. (Tabs P-2, U-9, and CC-3)
