UNITED STATES AIR FORCE  
**AIRCRAFT ACCIDENT INVESTIGATION**  
**BOARD REPORT**

**F-15C, T/N 80-0041**  
**NELLIS AFB, NV**

**LOCATION: NELLIS AFB, NV**  
**DATE OF ACCIDENT: 24 OCTOBER 2011**  
**BOARD PRESIDENT: LT COL DYLAN WELLS**  
*Conducted IAW AFI 51-503, Aerospace Accident Investigations*

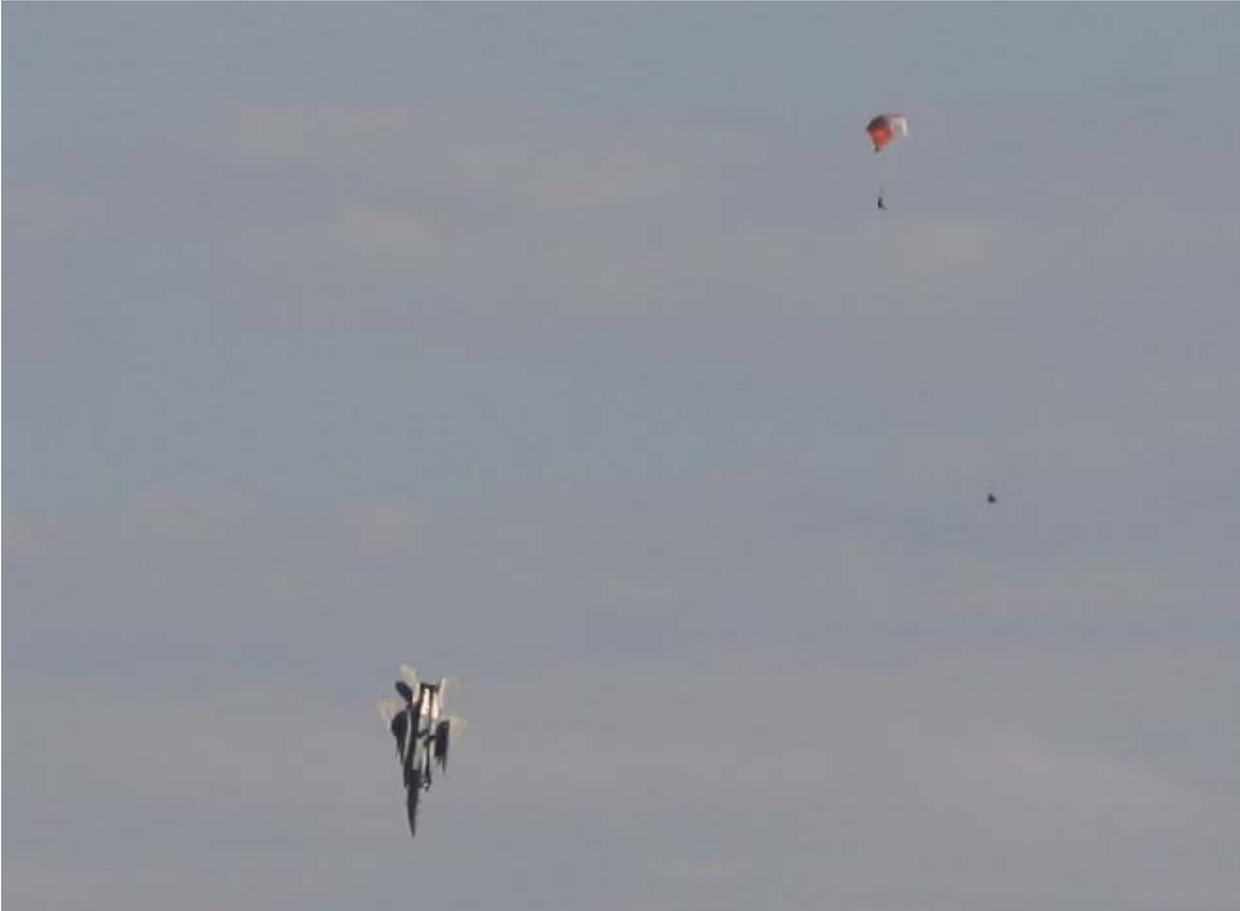
**Figure 3. MP Ejection (Tab S-17)**

After lowering the gear, the MA came out of the spin while passing 9,000 feet MSL. (Tab V-1.26) The MP neutralized the controls and selected maximum afterburner on both throttles. Based on the MP's memory of events and eyewitness photographs, the MA was around 50 degrees nose low when it started its recovery from the spin. (Tabs V-1.35, S-15) The MP attempted a slow application of aft stick pressure to fly the jet out from the dive, but realized he was at a very low altitude condition and was "starting to get that ground rush." (Tab V-1.33) Photographs taken near the mishap site show the MA's nose about 5 degrees above the horizon with an engine exhaust trail visible. (Tab S-15 to 16) Following this maneuver, the aircraft sliced aggressively to the left. As the MA passed below 7,000 feet MSL, the MP began his ejection sequence. Based on the eyewitness photographs, the pilot initiated his ejection sequence with the MA at around a 70-80 degrees nose low attitude, in a left bank. (Tabs V-1.36, S-16 to 17) Additionally, based on analysis of these photos, it was estimated that the ejection altitude was approximately 1,404 feet AGL or 5,586 feet MSL and the speed was approximately 122 KIAS. (Tab H-8) The MA impacted the ground a few seconds after the MP's ejection. The MP survived the ejection with very minor injuries. (Tab X-3)

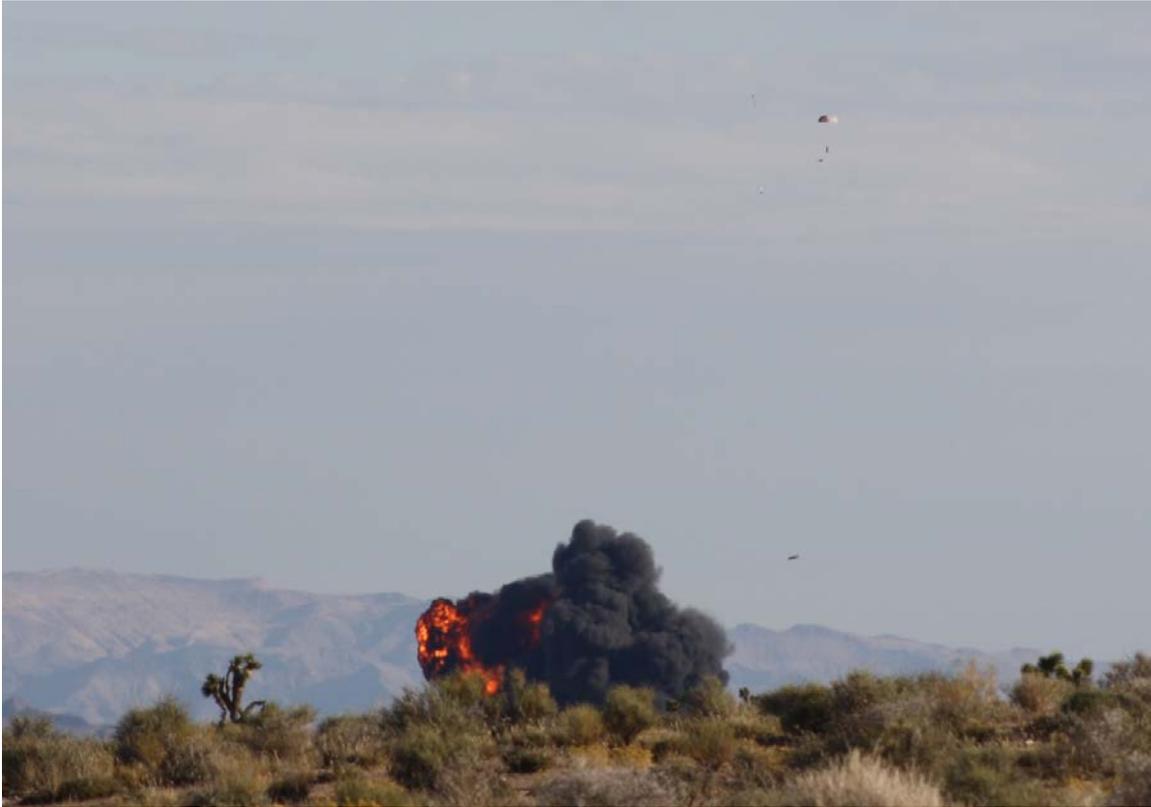
**Figure 4. Eyewitness Photo of MA Impact (Tab S-19)**

The MA impacted unoccupied BLM land approximately 10 miles north-northwest of Alamo, NV, at approximately 1603 local time. The coordinates of the impact site were N37 28 30.24 W115 15 53.79. (Tab S-3) Based on orientation of the crash site and witness photos, the MA heading was southeast and in a nose-low attitude at the time of impact. (Tab S-4, 17) The debris field covered a relatively small area with most of the wreckage found within a 100 yard radius of the center. (Tab S-5) On 4 December 2011, the AIB team found a 34-inch long portion of the right missile rail over half a mile north-northeast of the impact site. (Tab Z-3) There were no off-road vehicle tracks or apparent impact craters immediately by the rail. Two mishap responders were interviewed, and neither could explain how the wing rail ended up in the location where it was discovered by the AIB. They did state that if transported by ATV, the rail would have been in a non-enclosed box. (Tab V-8.6, 9.5) Unfortunately, no log was kept as to individual item transportation. (V-8.4) The missile rail appeared charred, indicating that it was likely on the aircraft at impact and not likely contributory to the mishap. (Tab Z-5) There were no civilian casualties or civilian property damage, and only minor environmental clean-up costs. (Tab P-5)

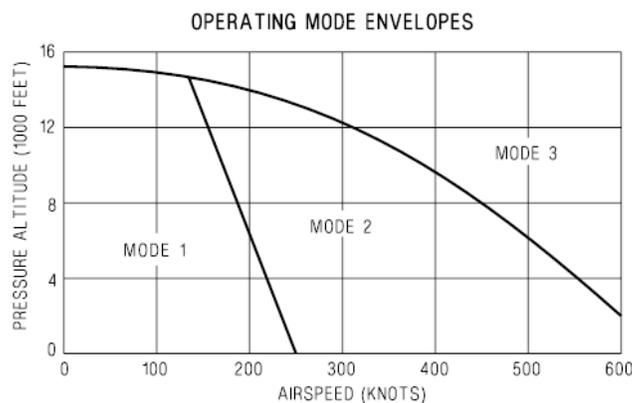
**Figure 6. Ejection Modes (Tab AA-79)**

The pilot initiated successful ejection within the performance envelope of the Advanced Concept Ejection Seat II (ACES II) ejection system. A Mode 2 ejection resulted, despite the MA being within the altitude and airspeed parameters for a Mode 1 ejection. A Mode 1 ejection should occur at airspeeds less than 250 knots equivalent airspeed (KEAS) and altitudes below 15,000 feet MSL. The mishap sequence never put the MA in a Mode 2 regime, as seen in Figure 6. The primary difference is that in a Mode 2 ejection, a seat drogue parachute is deployed, and the deployment of the aircrew parachute is slightly delayed. If a Mode 2 sequence is initiated in the Mode 1 regime (as in this case), there is increased risk that the aircrew parachute may not deploy completely due to the delay, increasing the likelihood of injury. In this mishap, however, the MP's aircrew parachute deployed fully and he sustained no serious injuries. (Tab H-3 to 9) Further investigation showed two other environmental sensors from the same lot number were locked in Mode 2 selection. (Tab I-12)

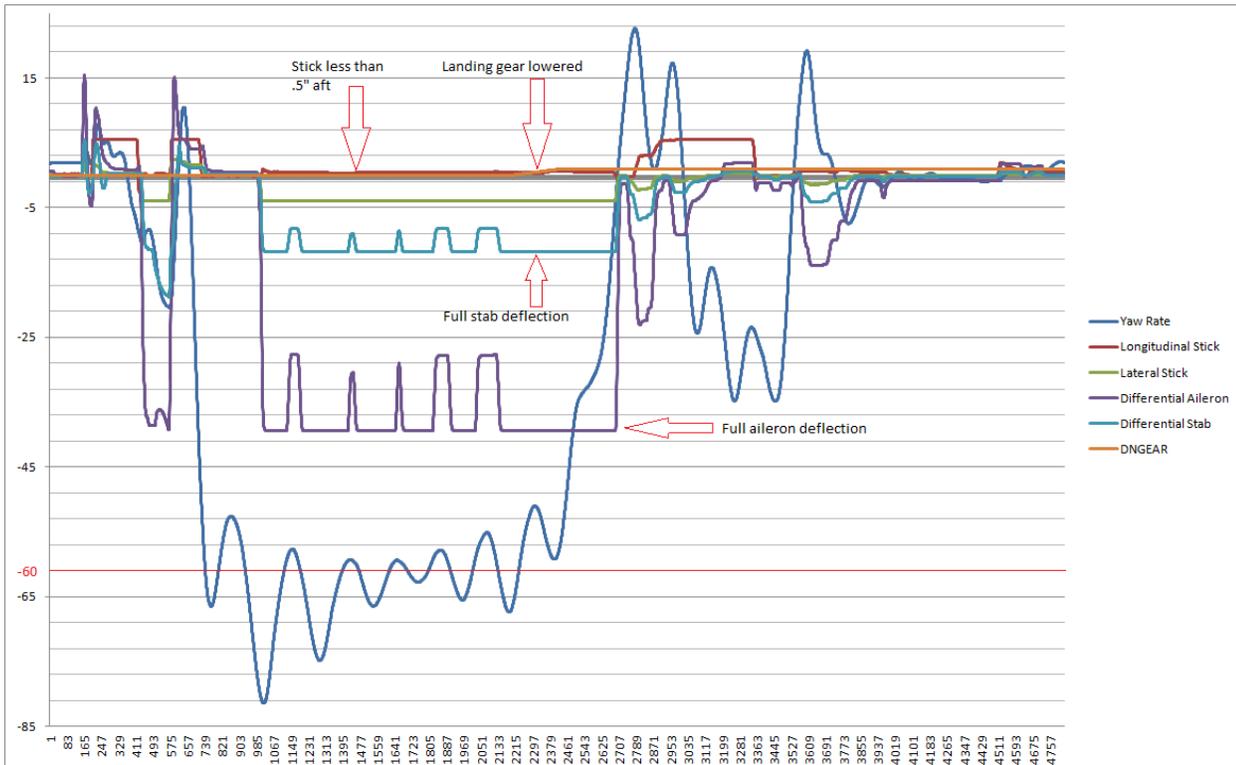
**Figure 8. Plot of simulator run Day 1 Run 27 (Tab HH-7)**

- This issue was confirmed in the simulator and is shown in Figure 8.

- Despite a concerted effort by the simulator pilot to place the stick in an exact longitudinal neutral position, this was never achieved. According to the T.O., the ratio of aileron/differential stabilator deflection to lateral stick motion is adjusted automatically based on airspeed, longitudinal stick position, and gear position in order to prevent adverse yaw. (Tab AA-5) The system that controls that function is the Lateral Ratio Changer. Figure 9 show the schedule followed by the Lateral Ratio Changer.
