UNITED STATES AIR FORCE
AIRCRAFT ACCIDENT INVESTIGATION
BOARD REPORT

F-16CM, T/N 89-2144

ACCIDENT LOCATION: BAGRAM AIR FIELD, AFGHANISTAN

DATE OF ACCIDENT: 8 OCTOBER 2010

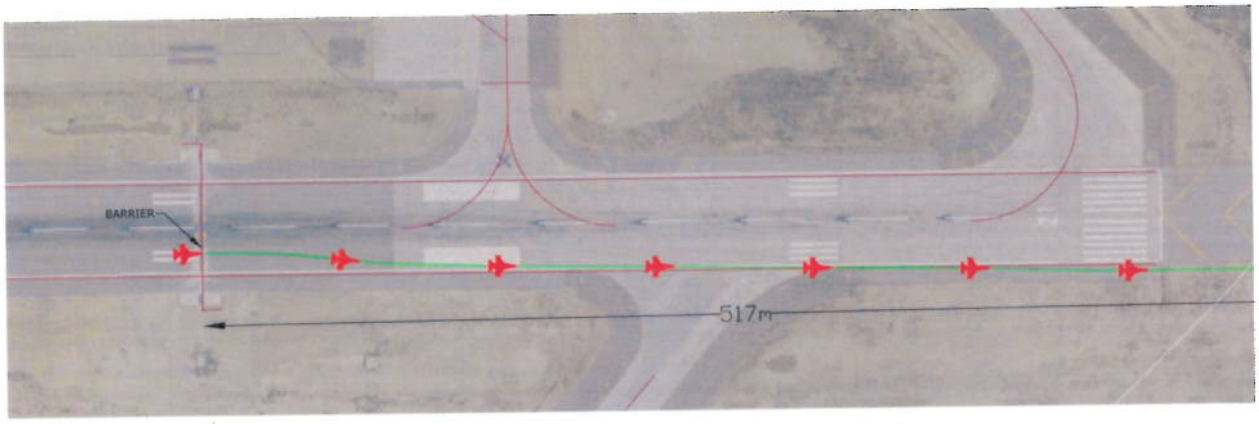
Figure 1. Diagram of MA Runway Landing Path

The MA's brake system has a redundant electrical and hydraulic design, allowing the pilot to switch to a different control channel should one fail. (Tab V-3.3) After switching to Channel 2, the MP first noticed the anti-skid caution light, indicating a failure possibly affecting braking performance. (Tab V-1.29, V-5.2) The MP immediately applied brakes and felt no braking action at all. The MP maintained full left rudder in an attempt to remain on the centerline. (Tab V-1.22) Data from the anti-skid control box indicated the right brake was responding normally throughout the landing. The data indicated the left brake malfunctioned and did not respond to the MP's inputs. (Tabs J-25 thru J-30, U-7, V-3.22, V-3.26) F-16 aircraft are capable of differential braking, which allows the pilot to control the left and right brakes independently. This capability allows the pilot to steer the aircraft simply through brake application. For example, if the pilot only applied the right brake, the plane would steer to the right. (Tabs V-3.35 thru V-3.36) Based on the MA's left brake failure, every time the MP applied the brakes, only the right brake functioned, causing the MA to veer to the right. (Tabs V-3.32 thru V-3.34) (See Figure 1)

After missing the cable, the MP reapplied brake pressure, pulling the MA further to the right due to the continued left brake failure. (See Figure 1) The MP then made a radio call to the Air Traffic Control tower that the MA was going off the end of the runway. (Tab V-1.19) The CSFDR data indicates the MA was traveling 67 knots as it departed the runway. (Tabs L-3 thru L-8) The MP shut the engine off prior to departing the edge of the runway. (Tab V-1.19)

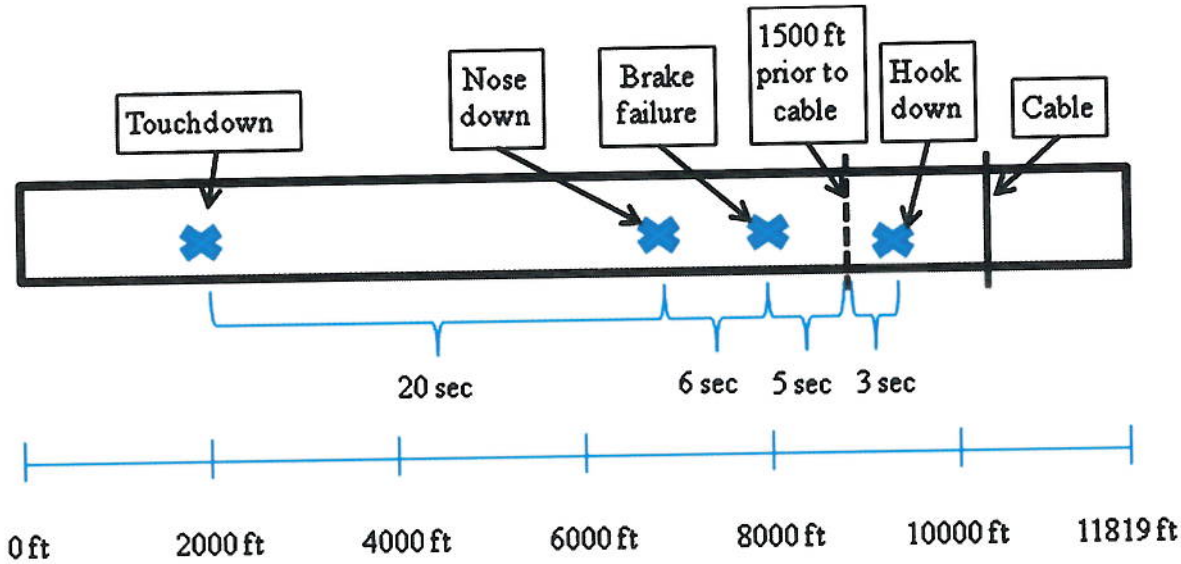
Figure 2. BAF Runway Diagram with Approximate Action Points

Based on CSFDR data, the MP only had five seconds to recognize and react to brake failure in order to lower the hook prior to 1500 feet. (Tabs L-3 thru L-8) In these five seconds, the MP would have to release all brakes, switch to Channel 2, reapply the brakes, recognize continued brake failure, and then lower the hook. It took the MP eight seconds to complete all of these actions. Therefore, the MP was unable to lower the hook within the 1500-foot parameter. (Tabs BB-14 thru BB-16) The MA passed over the cable but did not engage it. (See Figure 2) Figure 2 below is based on witness testimony, CSFDR data, and data from ground markings.

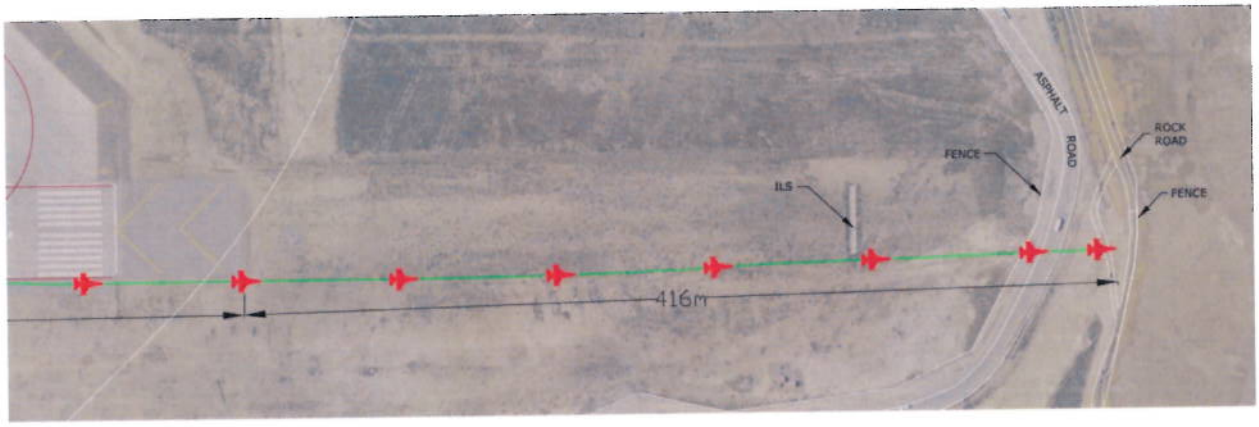
Figure 3. Diagram of Post-Runway MA Path

The MP continued using the rudder to steer the aircraft as it traveled approximately 1500 feet across the dirt, narrowly missing the Instrument Landing System antennas. (Tab V-1.20) The MP braced for impact as the MA passed through a chain link fence. The MA then impacted a raised perimeter road, which collapsed the landing gear. The MA then became airborne for a short distance and came to rest partially entangled in a second chain link fence. The MP performed an emergency ground egress at approximately 1720L. (Tabs V-1.20 thru V-1.21)

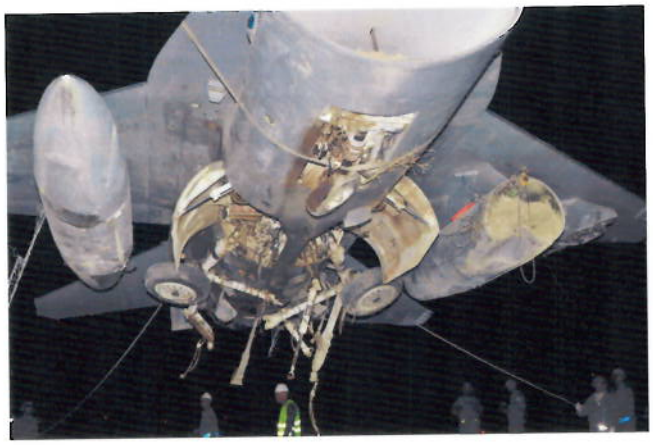
Figure 5. Post Impact Damage

The MA's fuselage remained mostly intact. The landing gear collapsed and all three struts sustained significant damage but did not separate from the MA. The nose landing gear components collapsed in the aft position consistent with normal retraction. Both main landing gear struts collapsed aft, opposite the normal forward retraction direction, resulting in substantial damage to the lateral structural bulkheads. All three tires and both main landing gear brake stacks remained attached to the landing gear struts. The forward fuselage was deformed with partial separation of the radome. Both wings remained attached, but sustained dents and abrasions along the entire leading edge. The horizontal and vertical stabilizers remained attached, with both the left and right horizontal stabilizer tips sustaining impact damage. Both ventral fins remained attached but sustained significant damage. (Tabs S-6 thru S-18)

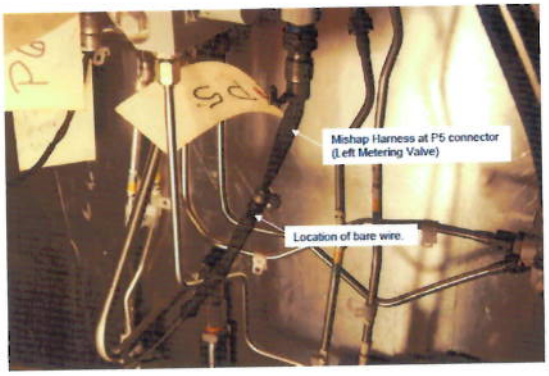
Figure 6. MA Wiring Harness

Chafing of the wiring harness created a condition where a bare wire came in contact with a clamp, resulting in metal-to-metal contact and a short circuit. This chafing occurred over time through normal wear and tear of the Kapton wire used when the MA was originally manufactured. No regular inspection would have revealed this chafing. (Tab U-9) The short circuit occurred in the wiring harness between the anti-skid control box and the left metering valve. The short circuit affected both redundant brake channels. (Tabs J-25 thru J-30, U-5 and V-3.27)

Due to this short circuit condition, which occurred during the landing roll, electrical signals between the anti-skid control box and the left brake metering valve were interrupted. This created a condition where the hydraulic pressure exerted on the left brake was substantially lower than the input from the pilot, causing left brake failure. (Tabs J-28 and U-9)

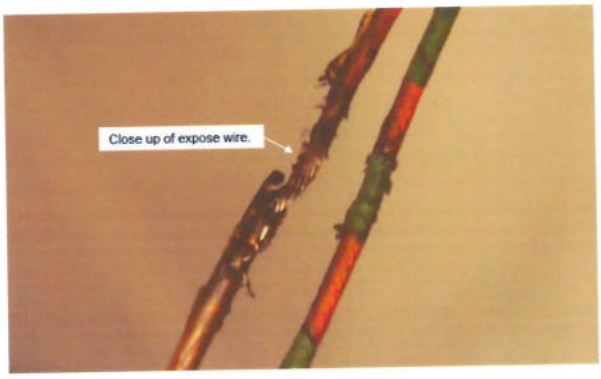
Figure 7. MA Exposed Wiring

During analysis of the data downloaded from the anti-skid control box, engineers determined that an electrical malfunction occurred during landing rollout. Through normal wear and tear, chafing of the main brake wiring harness caused a bare wire to come in contact with a clamp, resulting in metal-to-metal contact and a short circuit. Due to this short circuit, electrical signals between the anti-skid control box and the left brake metering valve were interrupted and caused failure of the left brake. This left brake failure caused the MA to drift to the right and fail to slow down before the end of the runway.

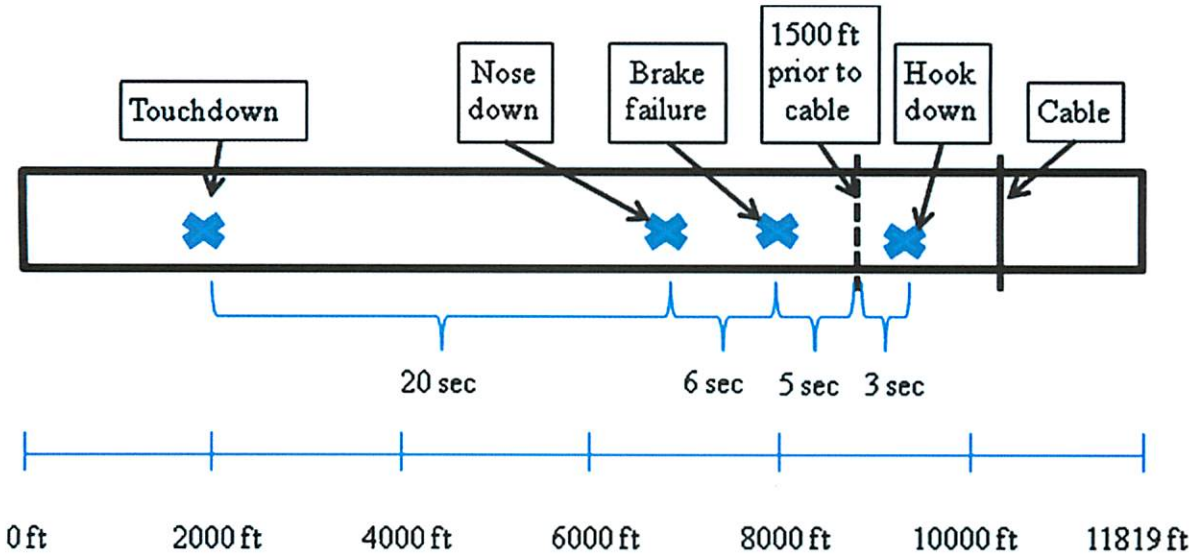
BAF Runway Diagram with Approximate Action Points

In addition, the MP assumed excess risk by accepting a touchdown 1500 feet beyond the recommended 500-foot touchdown point. With overconfidence in the MA's ability to stop, the MP pressed and accepted the risks of this long landing instead of going around for another attempt. Landing past the recommended touchdown point shifted the landing roll further down the runway and reduced the time available to react to the brake failure.

The above illustration portrays the relevant shifted and extended action points due to a long and heavy landing in this mishap. This left the MP with insufficient time to troubleshoot and effectively handle any complications during landing roll. Specifically, when the left brake failed, the MP took eight seconds to run through the first two steps of the brake failure checklist and lower the arresting hook. The MP actually had five seconds to lower the hook before the prescribed 1500 feet prior to the arresting cable. While the cable was suspended .25 inches below the prescribed height, it was still within operational range. I do not find that the cable's height was a factor in this mishap. Had the MA landed at the recommended touchdown point and fuel weight, the MP would have had more time to lower the hook within parameters and increase the likelihood of successfully engaging the cable.
