UNITED STATES AIR FORCE GROUND
ACCIDENT INVESTIGATION BOARD
REPORT

Tower Mishap Fatality
FOB Kalagush, Afghanistan

TYPE OF ACCIDENT: Class A Fatality

DATE OF ACCIDENT: 12 November 2010

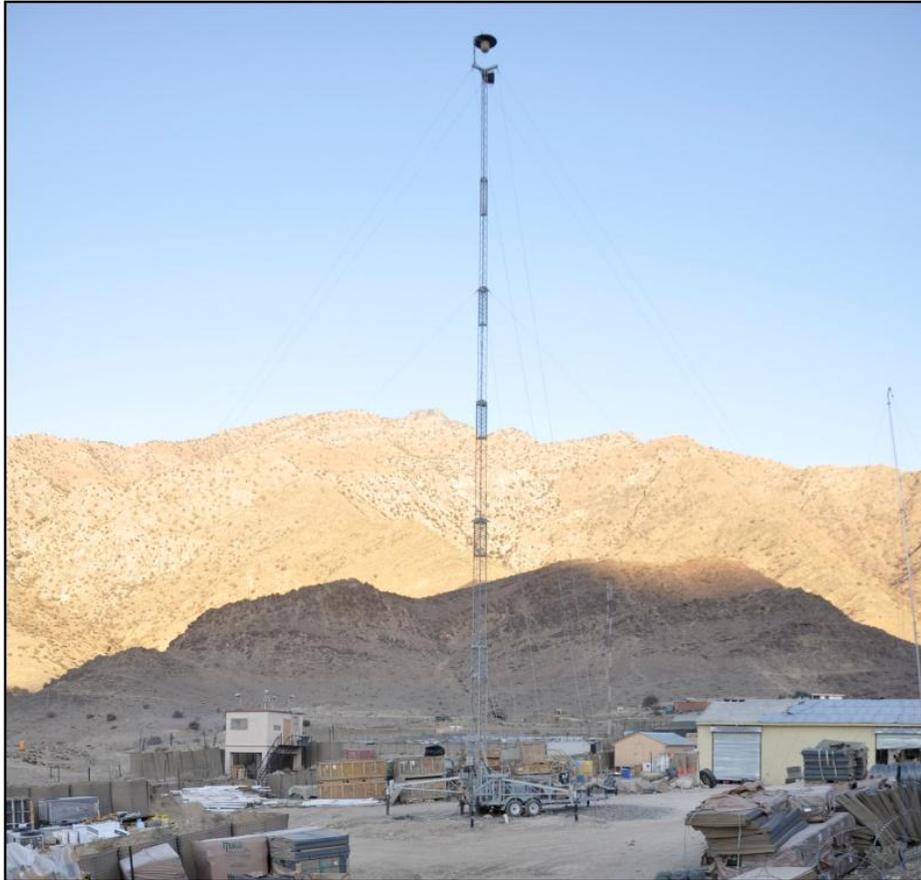
Figure 3. RAID Tower.

The tower, which is manufactured by US Tower Corporation (model number RMTU3107MDPL), has six heavy-duty steel telescoping sections mounted on a dual-axle mobile trailer. It is tilted to the vertical position with two hydraulic cylinders and then extended vertically with an electric winch. All sections of the tower telescope simultaneously from the base. The tower is supported by four heavy outriggers with leveling jacks and stabilized by the guy cables. It can support a payload of 650 pounds, has a transportable weight of 10,500 pounds, can be erected in wind speeds up to 30 miles per hour, and can sustain winds of up to 90 miles per hour when anchored. The tower deployed at FOB Kalagush, Tower 89, was installed there in May of 2007. Its payload included the sensor suite previously mentioned and weighed approximately 200 pounds. (Tabs V-52 and BB-16, BB-17, BB-18, BB-19)

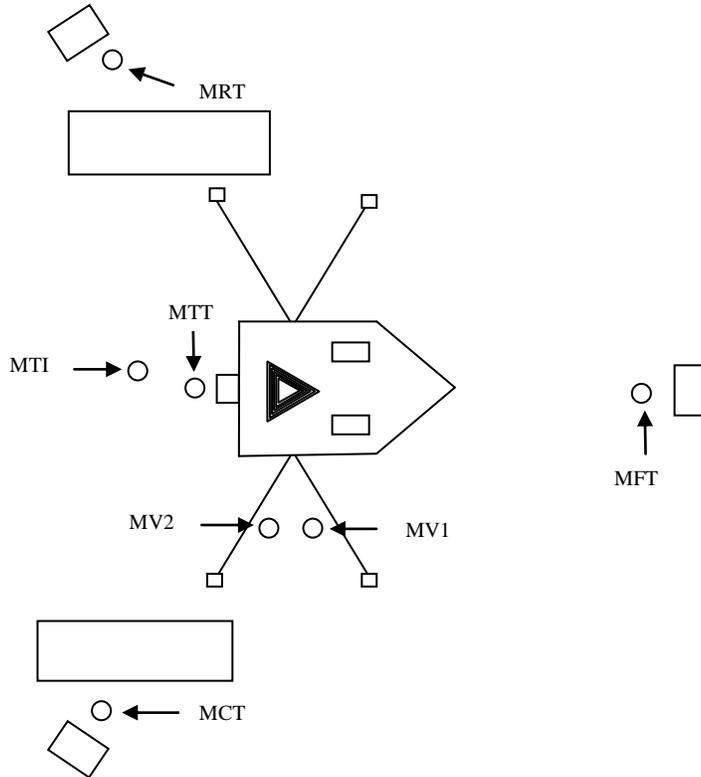
Figure 11. Approximate Location of Personnel When Raising Tower.

At an undetermined point during the extension process, MV2 approached the tower and stood in between the legs on the curb-side of the tower next to MV1. He began a conversation with MV1 about a personal family issue. Several trainees were involved in the conversation at various times, as was MTI. They were joking with MV2 and trying to cheer him up about the situation. (Tabs R-7, R-17, R-20, R-32, R-51, R-72, R-93, R-99, R-105, and V-11, V-12, V-35, V-61, V-62, V-90, V-95, V-99)

During the extension process, one of MCT's cables got caught on something on the tower (the exact cable and entanglement could not be determined), and either MV1 or MTI appeared to have fixed the problem. MCT at some point before the tower was fully extended began preparing the come-alongs at his anchor point. He could not see the control operator or those at the base of the tower due to the location of protective barriers, referred to as HESCO (Hercules Engineering Solutions Consortium) barriers (see Figure 11 below), between the anchor point and the tower. MFT was focused on his cables and climbed onto the front of the trailer to ensure that they did not become tangled. MTT was focused on the base of the tower watching the brakes, preparing to engage them. MRT had prepared his come-alongs and was sitting on his anchor smoking and awaiting instructions as the tower was extending. (Tabs R-3, R-7, R-10, R-12, R-
