UNITED STATES AIR FORCE
ABBREVIATED ACCIDENT INVESTIGATION
BOARD REPORT

MQ-1B, T/N 00-3072

**18th Reconnaissance Squadron
432d Air Expeditionary Wing
Creech Air Force Base, Nevada**

AIRCRAFT ACCIDENT INVESTIGATION MQ-1B, T/N 00-3072, CREECH AIR FORCE BASE, NEVADA 19 SEPTEMBER 2010

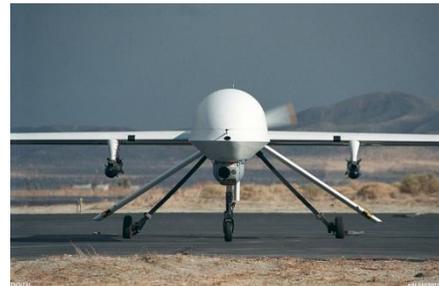
c. MQ-1B Predator System

The MQ-1B Predator aircraft is a medium-altitude, long endurance RPA. Its primary mission is interdiction and conducting armed reconnaissance against critical perishable targets.

The MQ-1B Predator is a fully operational system, not just an aircraft. This system consists of four aircraft systems (with sensors), a Ground Control Station (GCS), a Predator Primary Satellite Link (PPSL), and operations and maintenance personnel for deployed 24-hour operations. The basic crew for the MQ-1B Predator consists of one pilot and one sensor operator. They fly the MQ-1B Predator from inside the GCS via a line-of-sight (LOS) radio data link and via a satellite data link for beyond LOS flight. A ground data terminal antenna provides LOS communications for takeoff and landing while the PPSL provides beyond LOS communications during the remainder of the mission.
