UNITED STATES AIR FORCE
AIRCRAFT ACCIDENT INVESTIGATION
BOARD REPORT

MQ-1B, T/N 06-3175

**196th Reconnaissance Squadron
163d Reconnaissance Wing
March Air Reserve Base, California**

MQ-1B, T/N 06-3175, MARCH JOINT AIR RESERVE BASE 3 October 2009

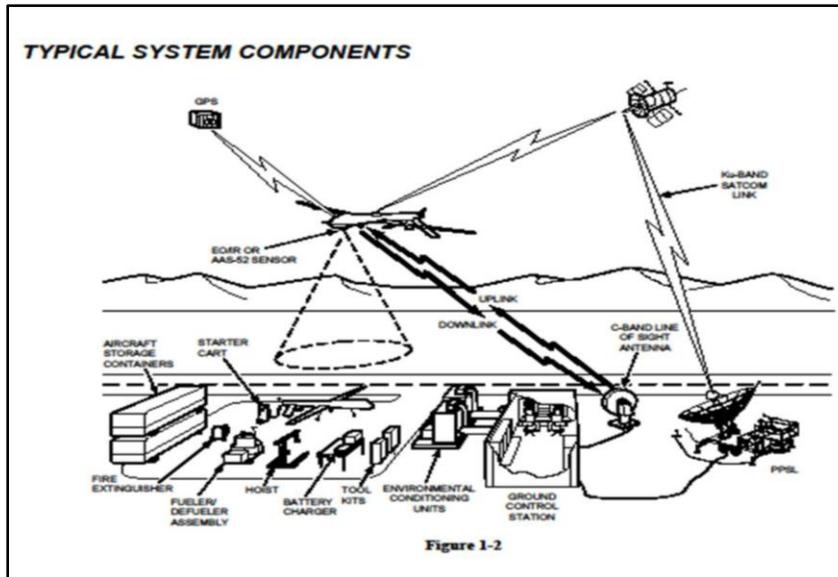
e. MQ-1B – Predator System

The MQ-1B Predator is a medium-altitude, long endurance, remotely piloted aircraft. Its primary mission is interdiction and conducting armed reconnaissance against critical perishable targets. (Tab CC-45, CC-46)

The MQ-1B Predator is a fully operational system, not just an aircraft. This system consists of four aircraft (with sensors), a Ground Control Station (GCS), a Predator Primary Satellite
